Manhole Inspection Summary

Manhole # S45I2_020MH

Insp Date: **1/10/08 10:05 AM**

Location Address: **4710 Pennington Ave**

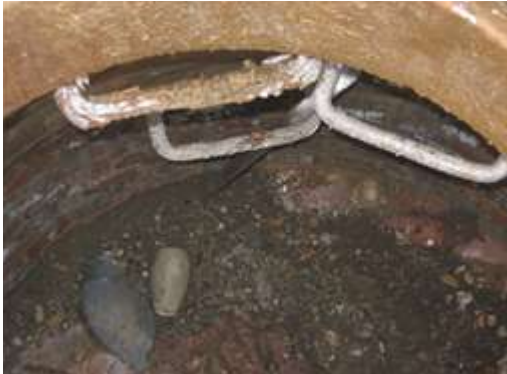
steps

Steps Count: **3** Missing: **0** ☒ **Corroded**

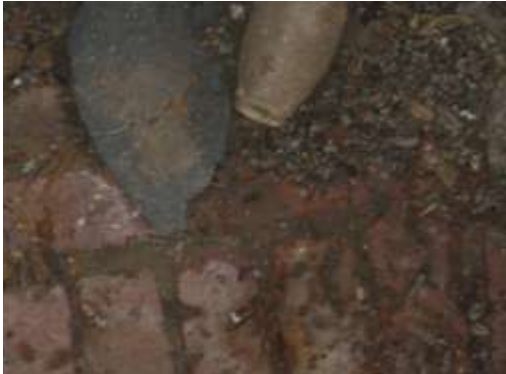
Defect 1

corroded

debris

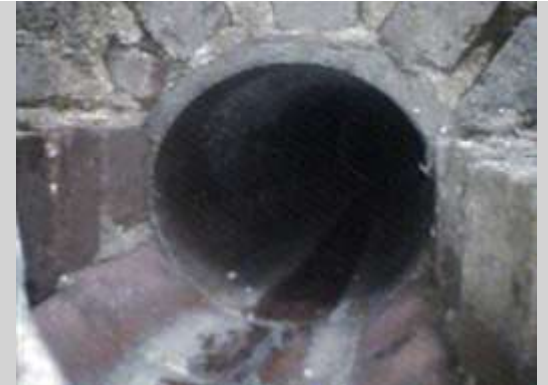
12 O'Clock Outflow

8 in. Circular Gravity Sewer
Pipe Out @ 12 O'Clock

Pipe Height: **10.8** (in.) Rod and Bar (Angled)
Pipe Material: **Clay** ☐ Pipe Lined
Invert Depth: **6.29** (ft.) Flow Characteristics: **Slow**
Deposits: ☒ None ☐ Mud ☐ Sludge ☐ Debris ☐ Grease
Silt Depth: (in.) Deposits Extent:
Infiltration: **None** Pipe Seal Cond: **Sound**

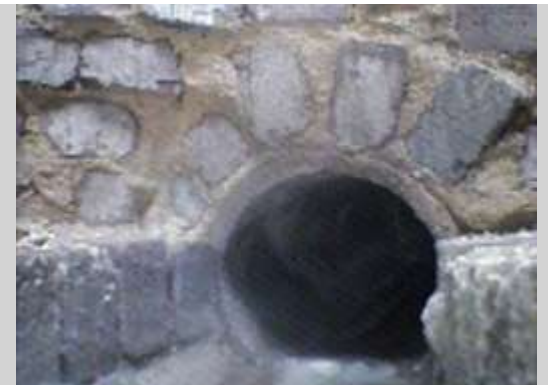
6 O'Clock Inflow

8 in. Circular Gravity Sewer
Pipe In @ 6 O'Clock

Pipe Height: **8.4** (in.) Rod and Bar (Angled)
Pipe Material: **Clay** ☐ Pipe Lined
Invert Depth: **6.19** (ft.) Flow Characteristics: **Slow**
Deposits: ☒ None ☐ Mud ☐ Sludge ☐ Debris ☐ Grease
Silt Depth: (in.) Deposits Extent:
Infiltration: **None** Pipe Seal Cond: **Sound**
